A Review of Current Knowledge

**CAUSES OF COPPER
CORROSION IN
PLUMBING SYSTEMS**

FR/R0007

Third Edition September 2017

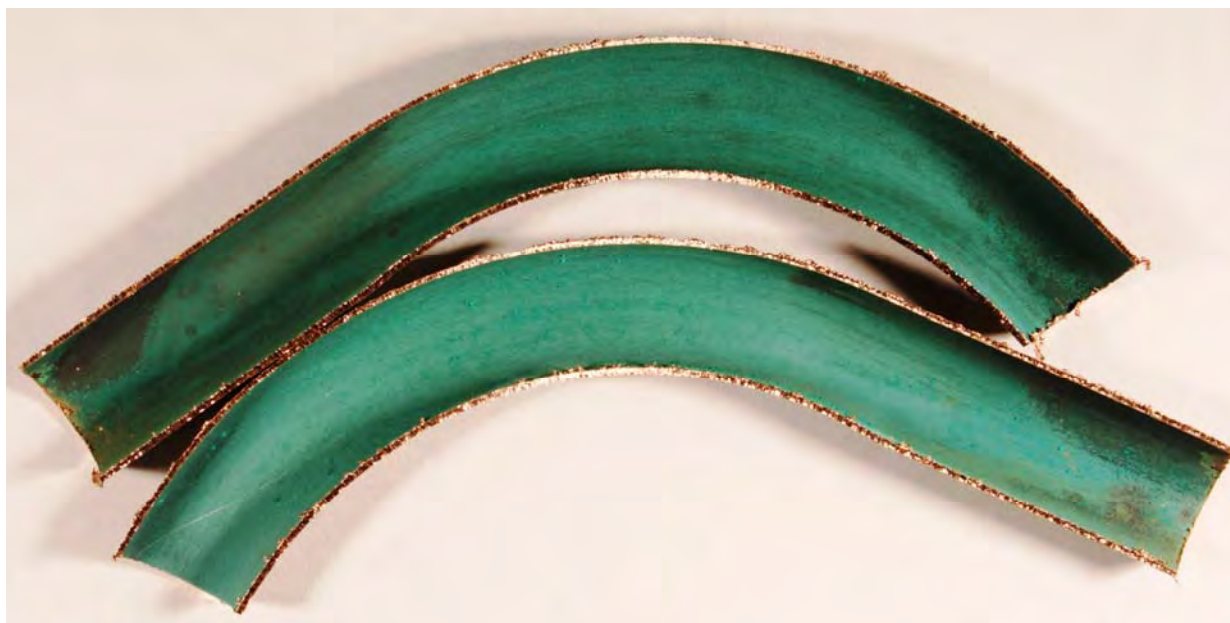
Figure 1 **Stable continuous malachite layer on bore of copper cold water pipe**
© P Munn

When copper pipes are first installed, they have a shiny metallic copper surface. On contact with aerated natural waters, copper ions will be released into the water due to corrosion of the copper. However, in flowing aerated water, surface films formed of copper corrosion products begin to form on the bore of the pipes, which quickly reduces the copper corrosion rate and copper levels in the water. In cold waters of near neutral pH, the stable film formed is the cuprous oxide or copper (I) oxide [Cu₂O], which in its pure state is ruby red but usually has a brown-black colour when formed on copper pipes. In hot water systems, the black cupric oxide or copper (II) oxide [CuO] is more stable. On top of these layers a green malachite or copper hydroxy carbonate [Cu₂(OH)₂CO₃] layer will begin to form within a few days. Eventually, the bore of the copper pipe will be covered with a stable protective patina of copper oxides overlaid with a continuous copper hydroxy carbonate layer, as shown in Fig. 1.

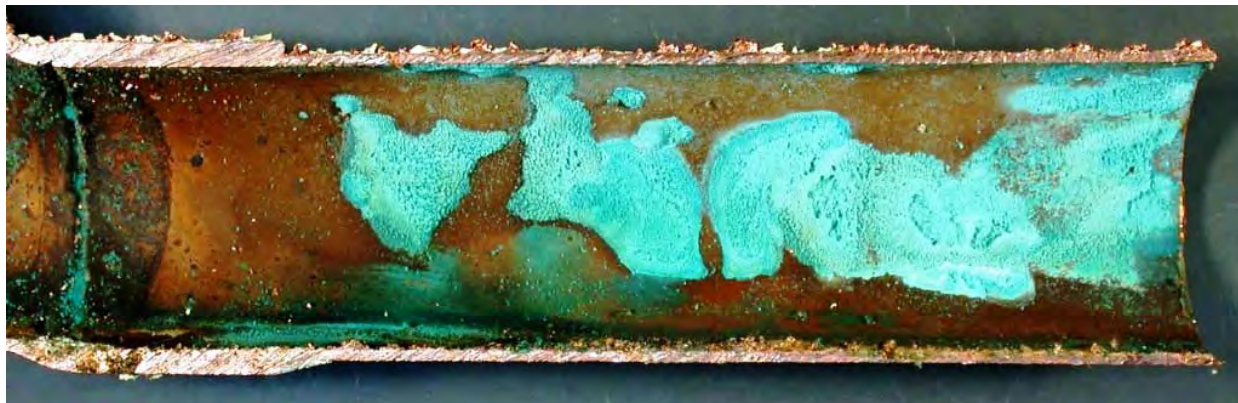
Figure 2 Build up of an unstable, irregular carbonate layer on the pipe bore, resulting in blue water © P Munn

Blue water may come about due to high concentrations of dissolved copper in the water or because of the release of particulate matter from loosely adherent copper corrosion products. Blue water may be produced if the dissolved copper concentration is above 1.5 mg/L. However, it is more commonly produced due to particles of insoluble copper corrosion products in the water, i.e. copper hydroxide, $\text{Cu}(\text{OH})_2$, or copper hydroxy carbonate or copper hydroxy sulphate. These may not be noticeable in a glass tumbler of water but become more apparent in a sink or bath full of water. If the blue water is caused by particulate matter, the particles will settle out on standing and the water will become clear. Severe staining of sanitary ware may occur, especially under taps in sinks and baths. Fig. 2 shows an

irregular, patchy carbonate layer on the bore of a copper pipe, which gave rise to blue water.

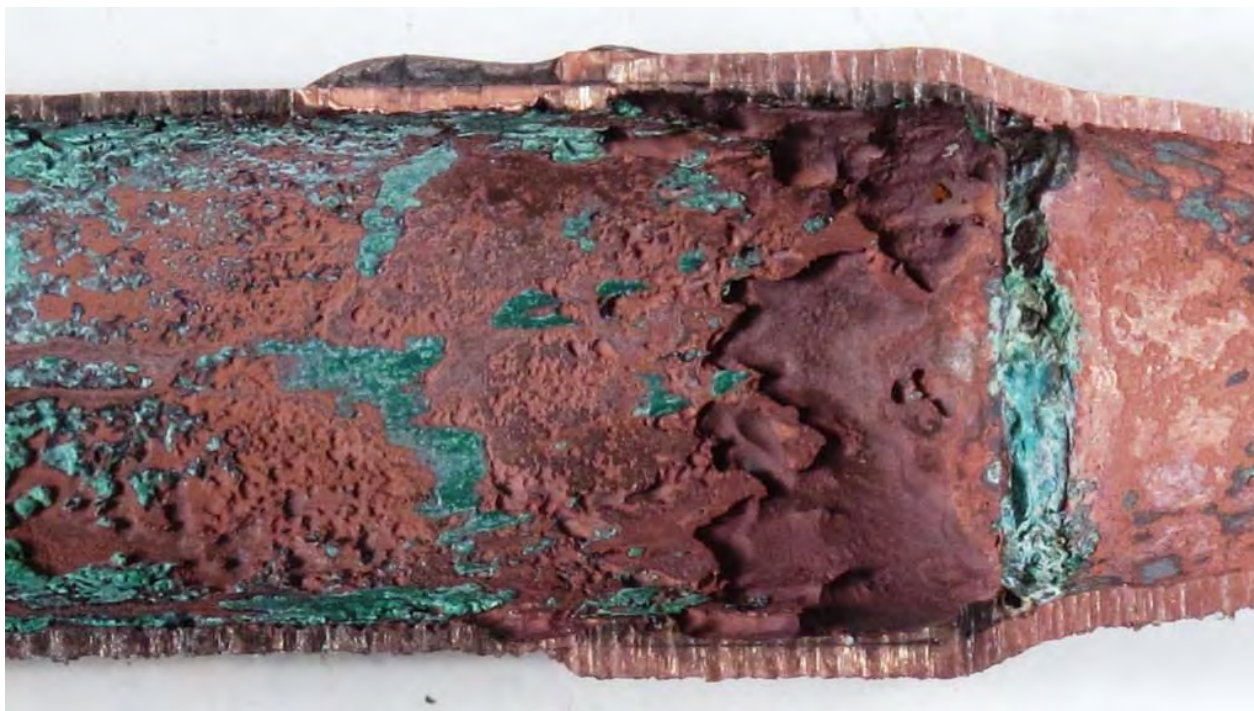
Figure 3 Erosion corrosion on hot water recirculating return pipe © P Munn

Erosion corrosion damage is easily identified by the appearance of localised shiny areas of copper with grooves or horseshoe shaped depressions within unattacked areas of copper, as shown in Fig. 3. Sometimes the pipe itself can become paper thin over a larger area while sometimes isolated pinholes can develop. The pits formed are steeply undercut on the leading edge, often giving rise to horseshoe grooves, with 'the horse' appearing to walk upstream.

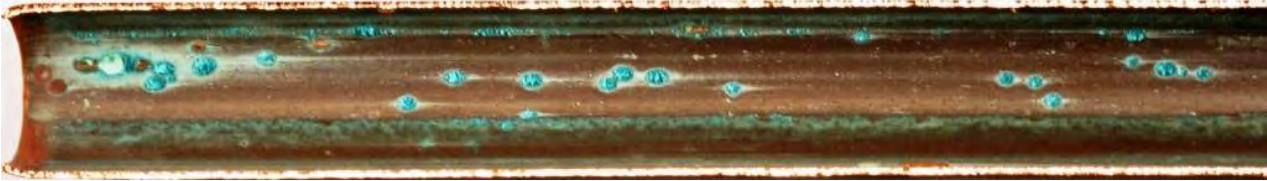
Figure 4 Type 1 pitting of cold water pipe © P Munn

Type 1 pitting can result in pinhole leaks in cold water pipes any time from a few months to a few years. The bore of the pipe shows mounds of green copper carbonate, which are usually spaced along the bore with larger mounds found along the bottom, see Fig. 4. When the mounds are removed by cleaning with acid, the underlying copper surface is found to contain hemispherical pits, sometimes containing white copper chloride crystals and ruby red copper (I) oxide. Fig. 5 shows a close-up of a Type 1 pit. A cross-section through a Type 1 pit is shown in Fig. 6. It can be seen that a membrane of copper oxide at the original copper surface separates the copper carbonate mound from the pit containing copper chloride crystals.

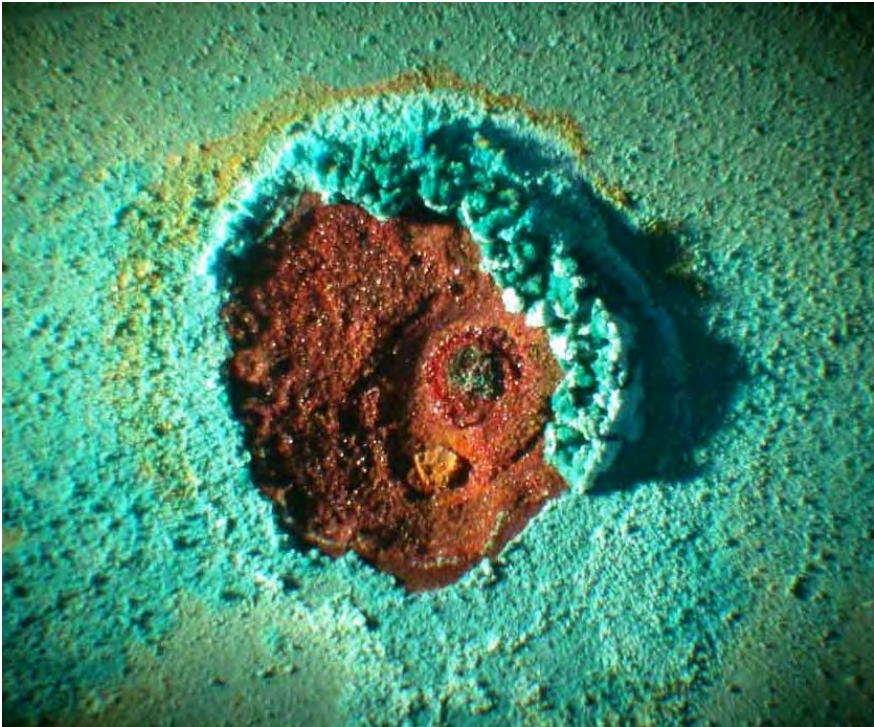
Figure 5 Close-up of Type 1 pit © P Munn

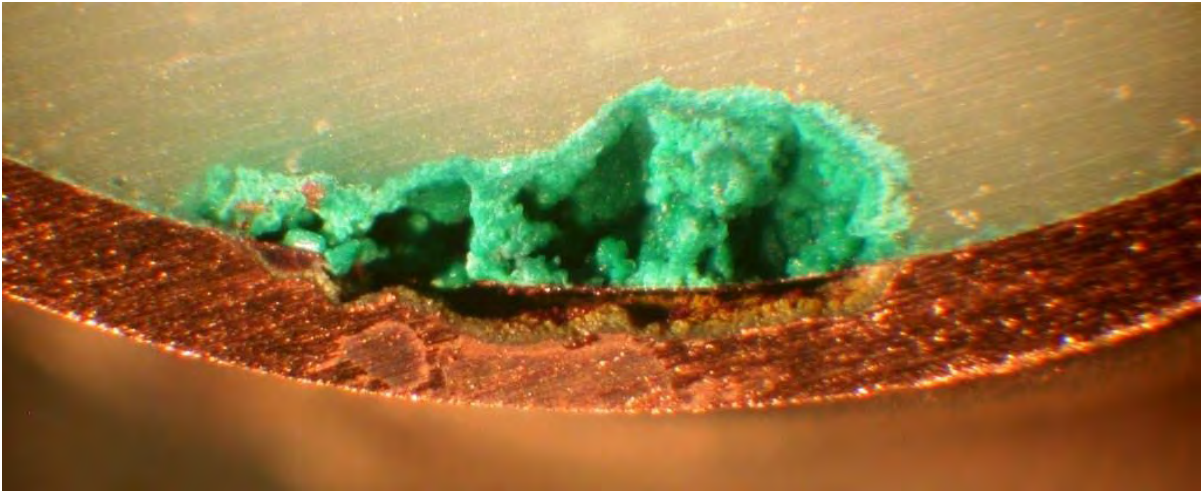
Figure 6 Cross-section through a Type 1 pit © P Munn

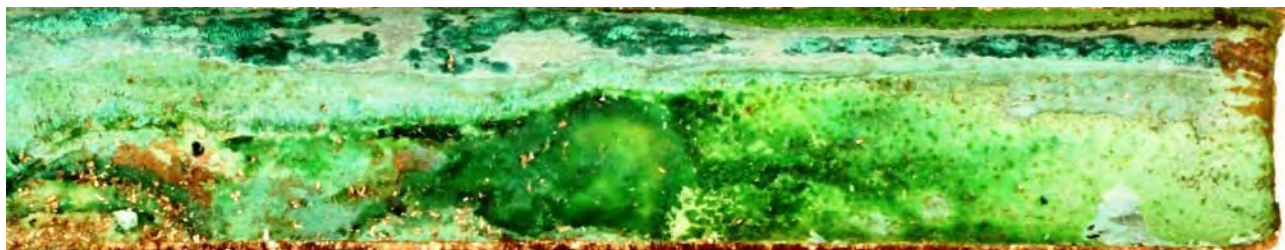
Figure 7 Flux run resulting in pinholing of cold water pipe (towards bottom edge of image) © P Munn

Nevertheless, it is something that can easily be avoided with a little care during the installation and commissioning of systems. Fig. 7 shows an example of a flux run which resulted in the pinholing of a copper pipe.

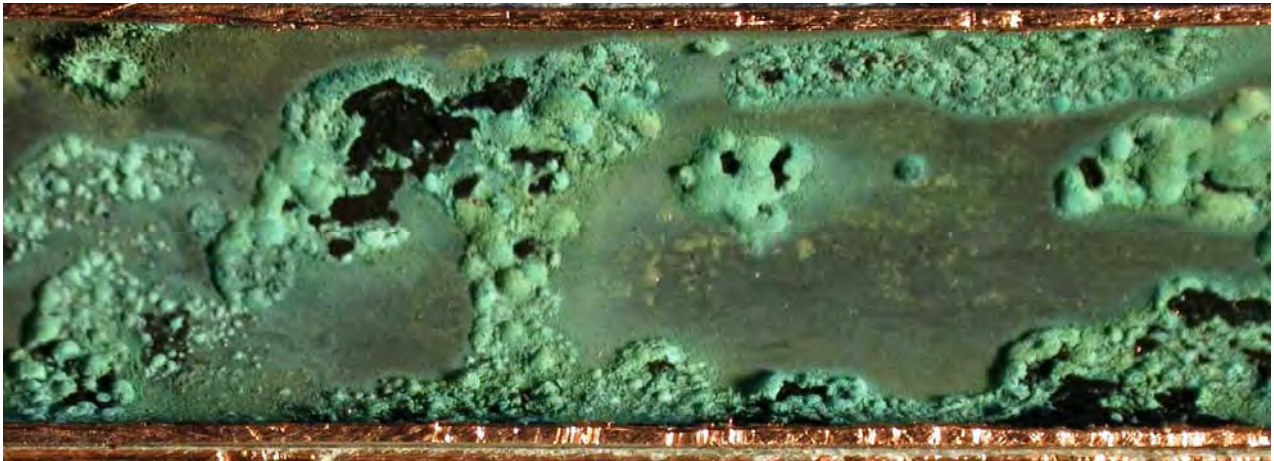
Figure 8 Microbial Influenced Corrosion on a cold water pipe © P Munn

Pseudomonas. A classic form of MIC is the presence of a high density of tiny pits, known as ‘pepper-pot corrosion’ underneath the surface layers. However, they can also appear as hemispherical pits surrounded by, or coalescing with, much smaller pits. Fig. 9 shows an example of pepper-pot corrosion caused by MIC, revealed after cleaning the surface with dilute acid.

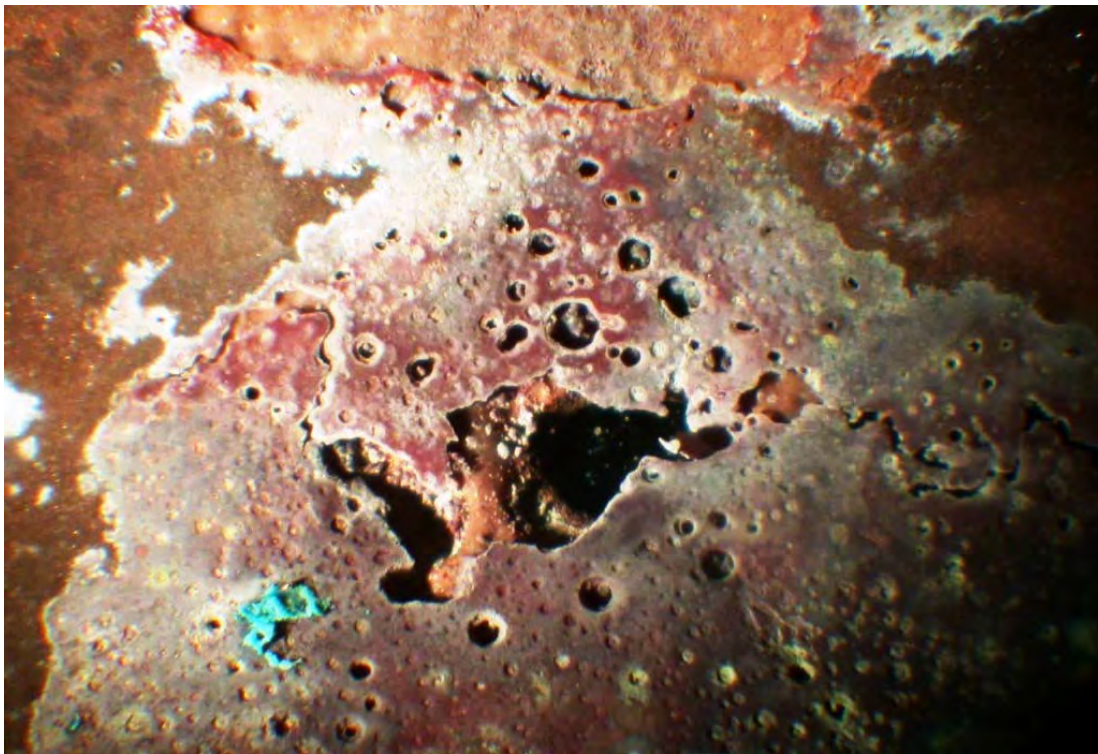
Figure 9 'Pepper-pot' corrosion caused by MIC © P Munn

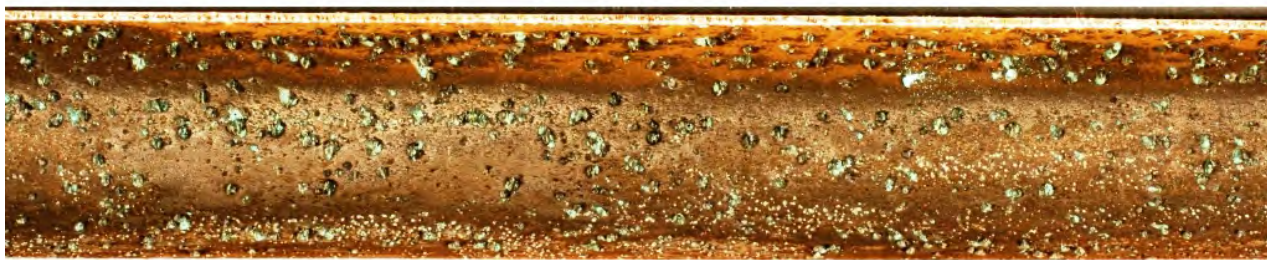
Figure 10 Type 2 pitting in a hot water pipe © P Munn

These deep pits are not normally covered with corrosion products. The pits have a narrow mouth and an irregular internal geometry. They are filled with crystalline copper (I) oxide [Cu₂O], sometimes capped by blue basic copper sulphate. Type 2 pits grow much slower than Type 1, with leakage of pipes occurring between 8 and 12 years. Fig. 10 shows an example of Type 2 pitting while Fig. 11 shows a cross-section through a Type 2 pit.

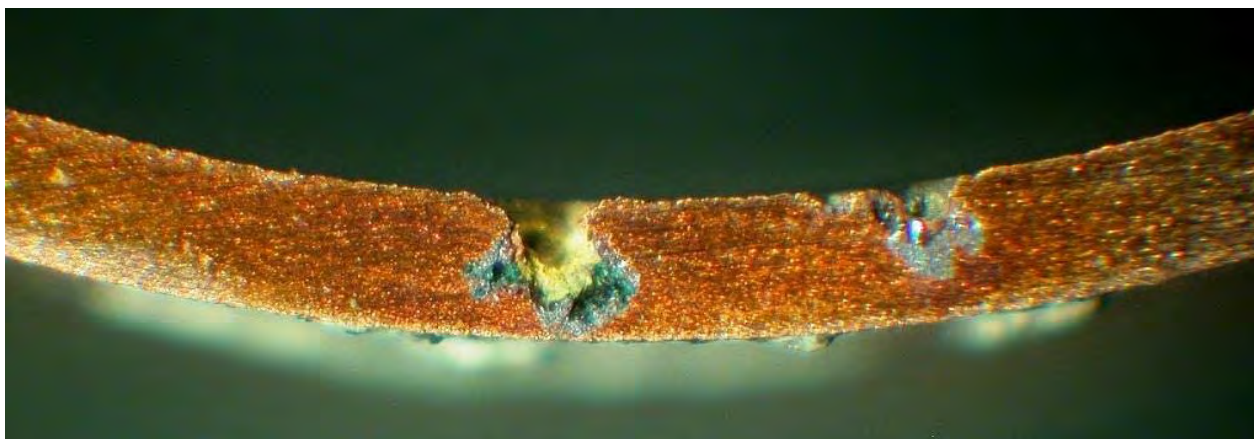
Figure 11 Cross-section through Type 2 pits © P Munn

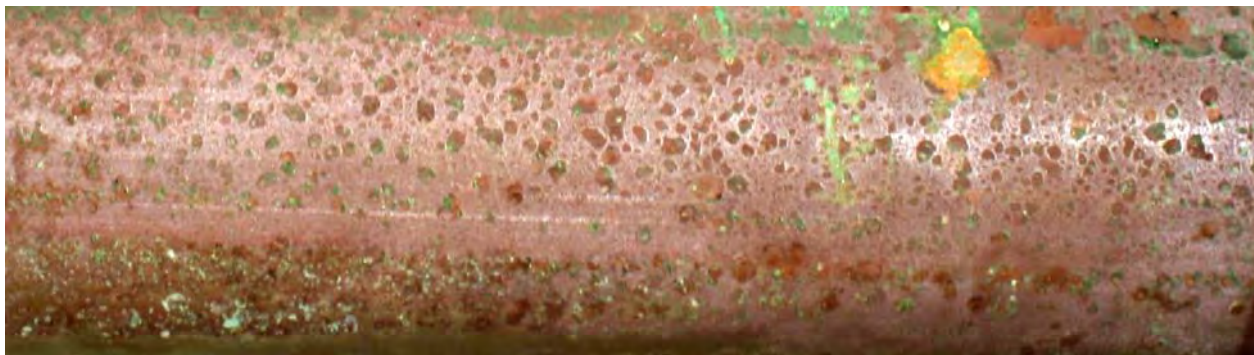
Figure 12 Appearance of formicary corrosion on the outside of copper pipe after removal of lagging © P Munn

Since the corrosion takes place under lagging, the first thing that is noticed is the lagging becoming wet and dripping. After removal of the lagging, the underlying copper pipework is discoloured, often having a very dull or blue-purple appearance, as shown in Fig. 12. The pits are too small to be seen with the naked eye but when cross-sections are taken through the area of attack and viewed under a microscope, numerous twisting and interlocking tunnels are observed, as shown in Fig. 13. This is why the attack is sometimes called ‘ant’s nest corrosion’.

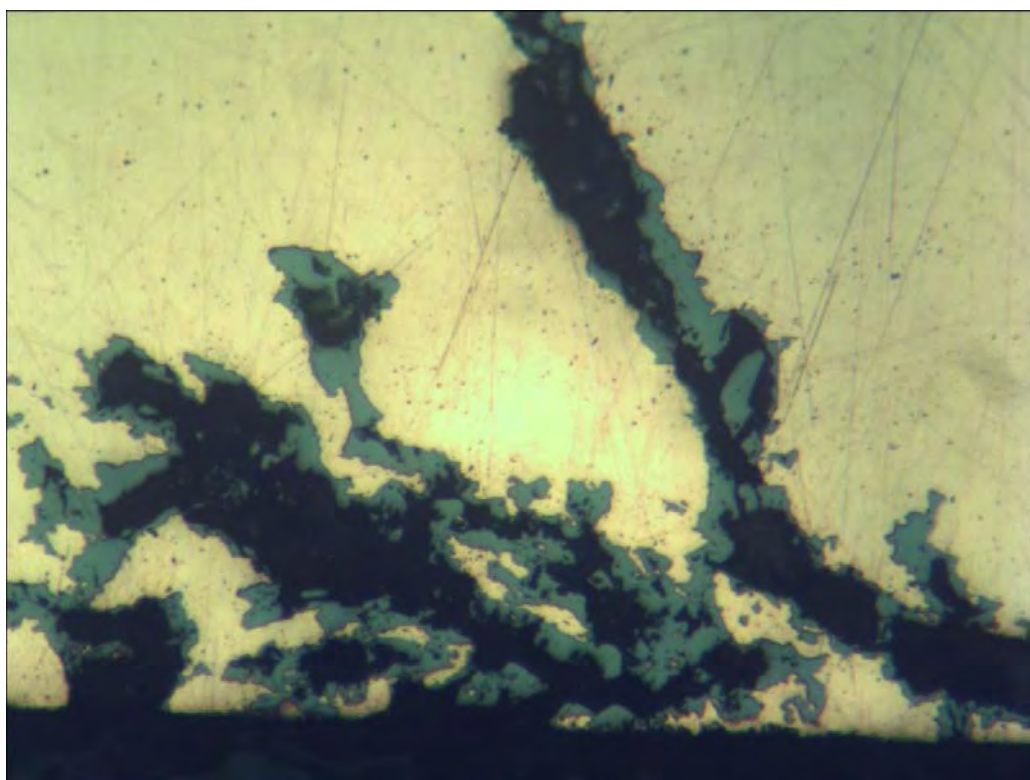
Figure 13 Cross-section through formicary attack (outer edge of pipe at bottom) © P Munn

Formic acid or other carboxylic acids leaching from the phenolic foam attack the copper by forming a complex of cuprous formate. This oxidises to copper (I) oxide which, because it has a larger volume, results in fine cracking. Exposed copper then reacts further with the formic acid leading to deeper, more convoluted cracking. For any attack to occur, the presence of moisture is required. The moisture can be present within damp insulation at the lagging stage or may condense from the atmosphere and penetrate through insulation without a barrier layer or at cut ends of insulation.

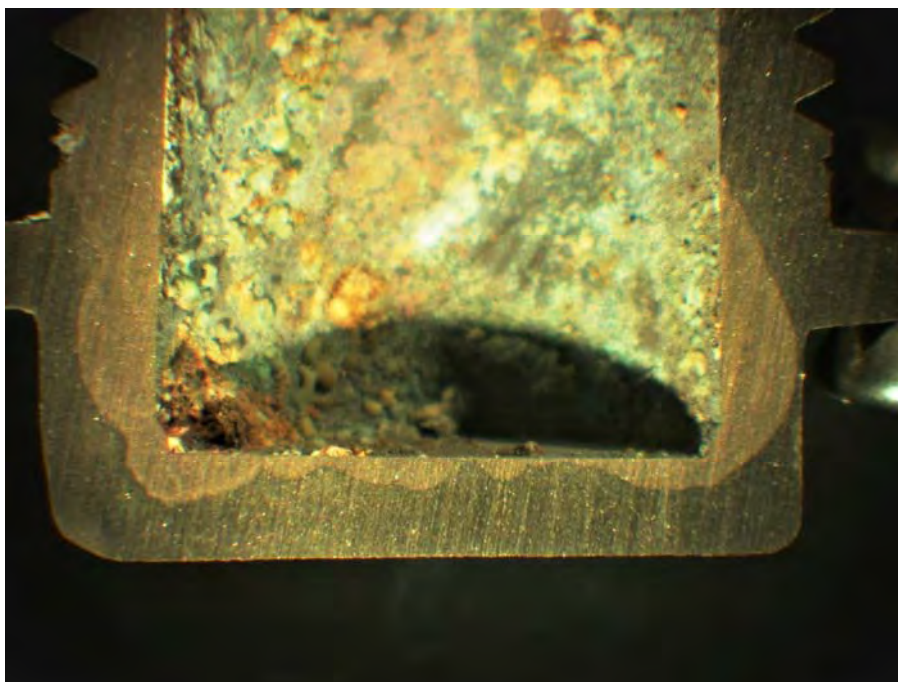
Figure 14 Meringue type dezincification in a brass fitting © P Munn

The normal yellow colour of the brass becomes a more reddish colour. In meringue type dezincification, voluminous corrosion products can cause blockages in fittings. The brass fitting itself becomes mechanically weak and can eventually fail, leading to leakage. Fig. 14 shows a cross-section through a brass fitting which has suffered from meringue type dezincification. The depth of the attack can be clearly seen in the polished cross-section.

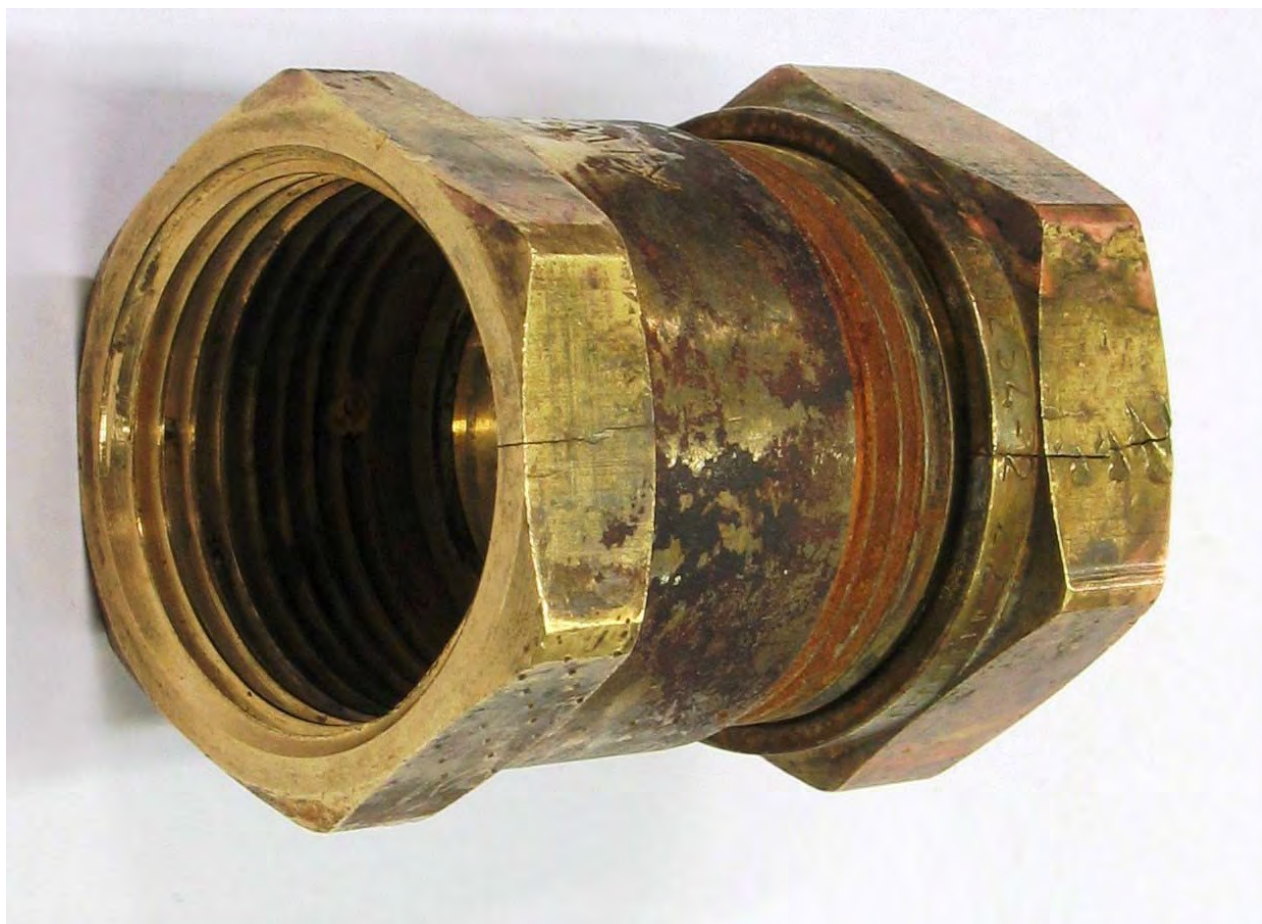
Figure 15 SCC in a brass fitting © P Munn

Leaks at brass fittings occur under foam insulation. When the insulation is removed, cracks are visible in the fitting, in particular in the threaded nuts, which are under tensile stress (see Fig. 15)
