CAUSES OF COPPER CORROSION IN PLUMBING SYSTEMS

Author: R J Oliphant

A Review of Current Knowledge

FR/R0007
February 2003
Revised May 2003

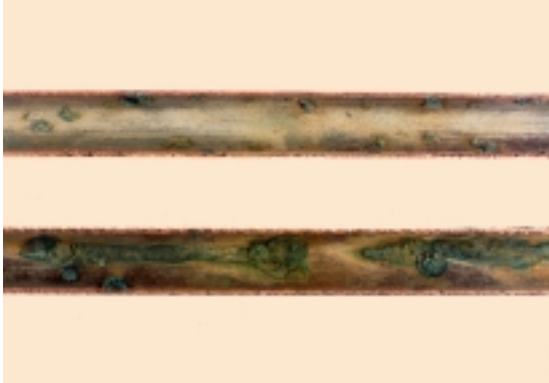
Photograph 1. Typical distribution of Type I pits in copper pipe

Characteristic features. Corrosion deposits are deep green, semi-isolated mounds above pits or pinholes in the pipe wall (see Photographs 1 and 2). Typically the pipe or cylinder fails in a short period of time, usually between three and four years but sometimes within a few months. Two or more factors need to be present for Type I pitting damage to occur.

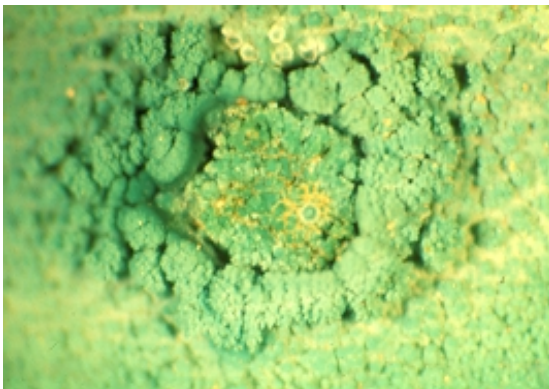
Photograph 2. Detail of a Type I pit with a central mound of malachite above the initiating site surrounded by secondary mounds above daughter pits.

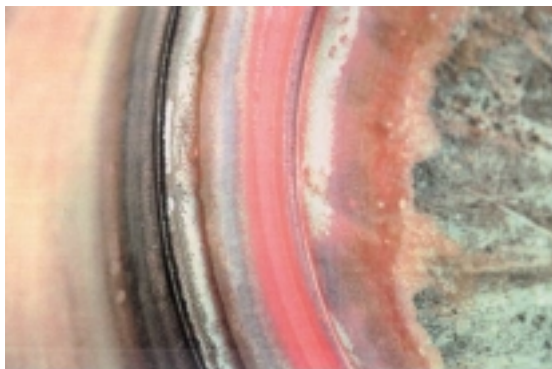
Photograph 3. View of the internal surface of the base of a hot water cylinder (after the removal of all loose deposits) showing the broad intensely red corrosion product layer in the peripheral crevice where Rosette corrosion has become initiated.

Characteristic features. Heavy sediments of an aluminium corrosion product that vary from white with a bluish tinge to light green in colour. Underneath these deposits, the copper is a vivid brick red magenta colour (see Photograph 3) consisting of large platelets of cuprous oxide separated by deep trenches; hence the original name ‘Rosette pitting’. However, it is probably more accurately described as a general attack due to the development of highly corrosive conditions beneath the aluminium corrosion deposits. Failure occurs due to the thinning of the cylinder wall eventually leading to perforation.

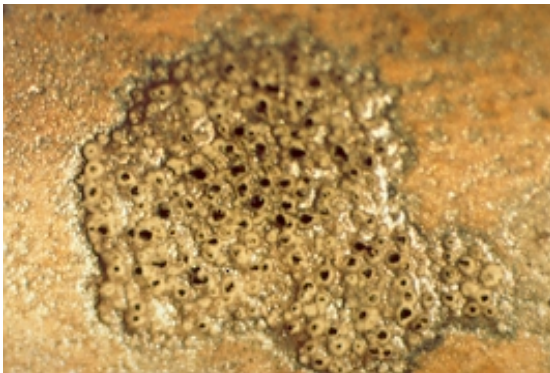
Photograph 4. An acid cleaned copper pipe surface showing 'pepper pot corrosion' produced by microbiological action.

Characteristic features. Pitting consists of copper tubercles, often above multiple initiation sites ('pepper pot corrosion'), overlaid with a black precipitate (see Photograph 4). General corrosion also leads to the sporadic release of copper into the water. Leakage in the pipework occurs as a result of the thinning of the wall. Pitting can occur in both hot and cold water systems.

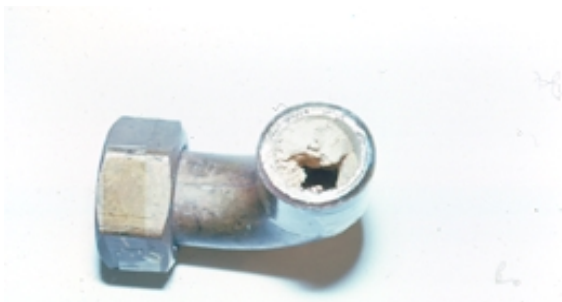
Photograph 5. A Brass fitting partially blocked by meringue dezincification

When the pH of the water is greater than 8.2, the corroded zinc precipitates in the bore of the fitting, usually as hydrozincite (a basic zinc carbonate) greatly reducing the flow of water. This form of attack is known as 'meringue dezincification' and is the form that leads to most frequent complaints from the consumer because it happens in a relatively short period, typically from six months to five years (see Photograph 5).
