A Review of Current Knowledge

**CAUSES OF COPPER
CORROSION IN
PLUMBING SYSTEMS**

FR/R0007

Third Edition September 2017

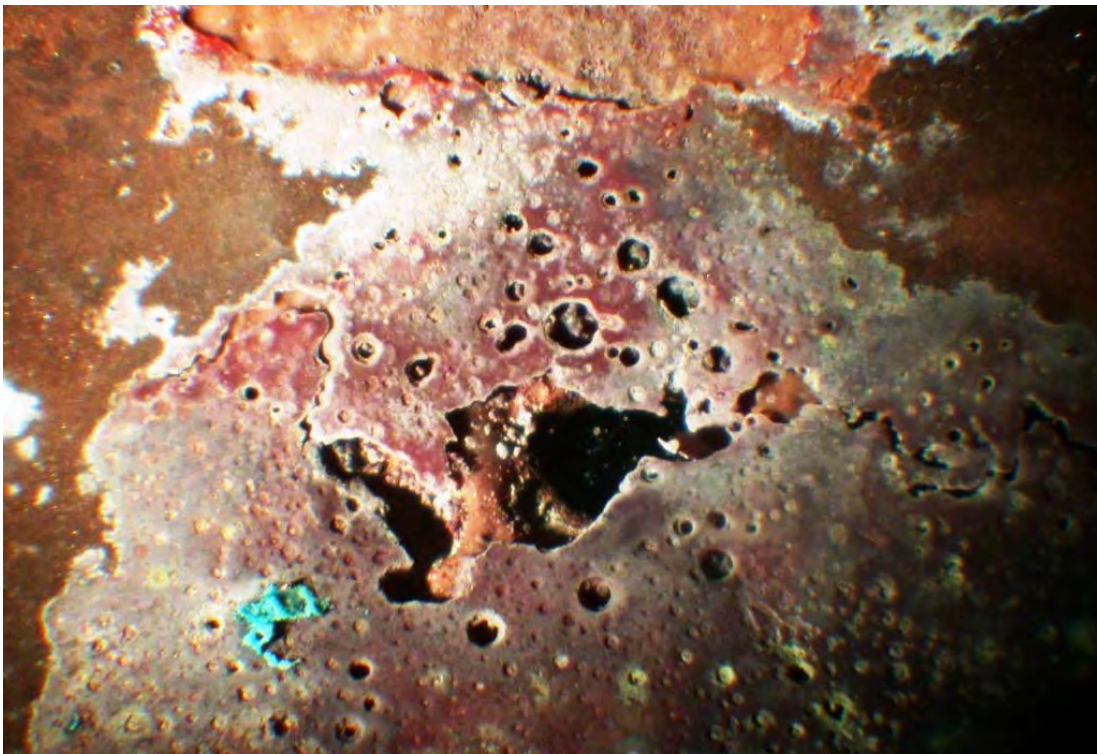
Figure 9 'Pepper-pot' corrosion caused by MIC © P Munn

Pseudomonas. A classic form of MIC is the presence of a high density of tiny pits, known as ‘pepper-pot corrosion’ underneath the surface layers. However, they can also appear as hemispherical pits surrounded by, or coalescing with, much smaller pits. Fig. 9 shows an example of pepper-pot corrosion caused by MIC, revealed after cleaning the surface with dilute acid.
